DOT/FAA/AR-99/8,IV

Improved Barriers to Turbine Engine Fragments: Interim Report IV

June 2002

Interim Report

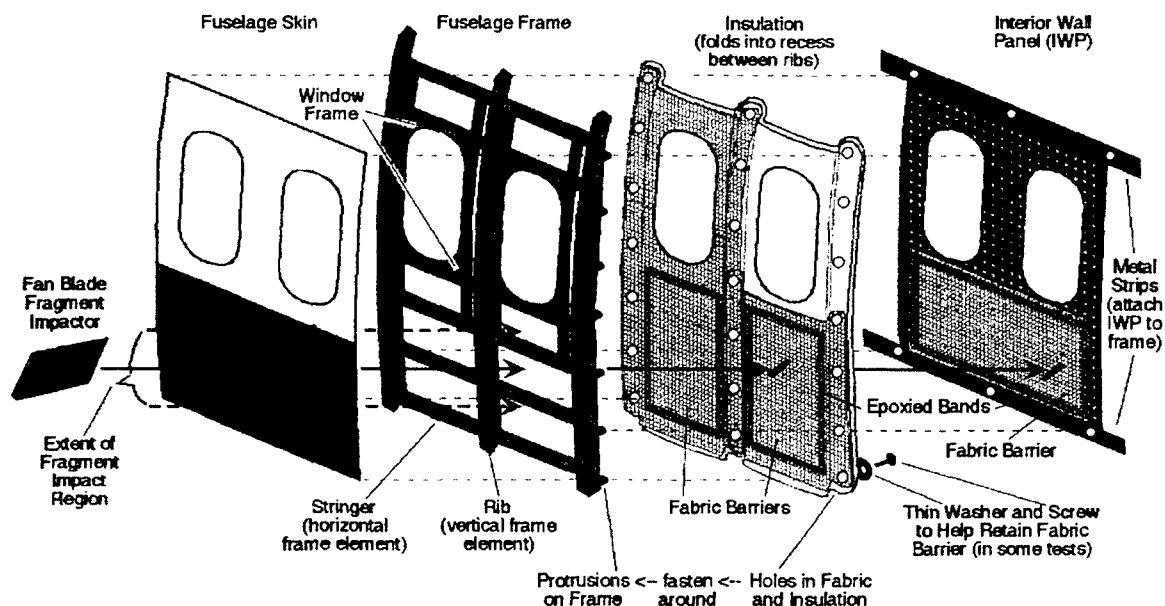
FIGURE 1. EXPLODED VIEW OF FUSELAGE WALL SHOWING REGIONS OF FRAGMENT IMPACT AND VARIOUS LOCATIONS OF FABRIC BARRIERS FOR OCTOBER 1999 TESTS AT CHINA LAKE

The fabric barriers consisted of three to ten plies of Zylon 35 x 35 weave, except for one test which used Kevlar 32 x 32 weave and one with Spectra 32 x 32 weave. The arrangement of the fabric barriers within the fuselage wall is shown in figure 1. The fabric barriers were usually cut approximately the same width as the insulation blankets (see figure 1), and holes were cut near the vertical edges of the fabric at the same location as the holes in the insulation. For most tests, the fabric plies were glued to the insulation blanket (using epoxy along a thin rectangle near the fabric periphery) as shown in figure 2, and the holes in the fabric and insulation blanket were fastened around the protrusions in the fuselage frame ribs. Since the horizontal distance between the holes on the fabric was significantly greater than the distance between adjacent frame ribs (the fabric and insulation fold down into the recess between the ribs), there is substantial room for fabric stretching and deformation before the fabric tightens against the rib protrusions. For some tests, the barrier extended over three vertical fuselage frame segments but was glued to the insulation blanket only in the middle segment, the segment in which impact occurred.

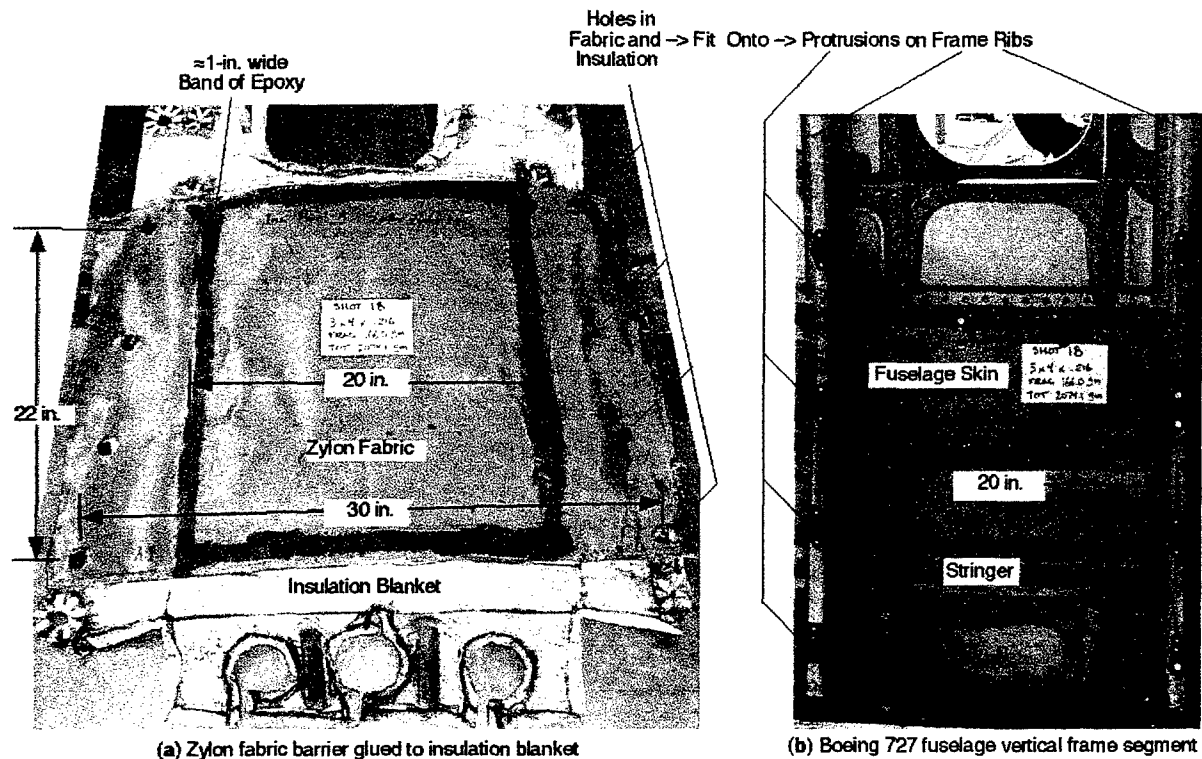
FIGURE 2. PRETEST PHOTOS OF ZYLON BARRIER AND REGION IN FUSELAGE WHERE IT WAS PLACED

In most tests, the fabric extended vertically from the bottom of the window to the third stringer below the window, a distance of about 24 in. (62 cm). Although in a few tests, some of the fabric plies extended vertically up to one stringer past the window frame, a distance of 49 in. (124 cm). In one test, the last ply was glued to the interior wall panel, and in another test, the first ply was unheld (merely taped lightly in place).

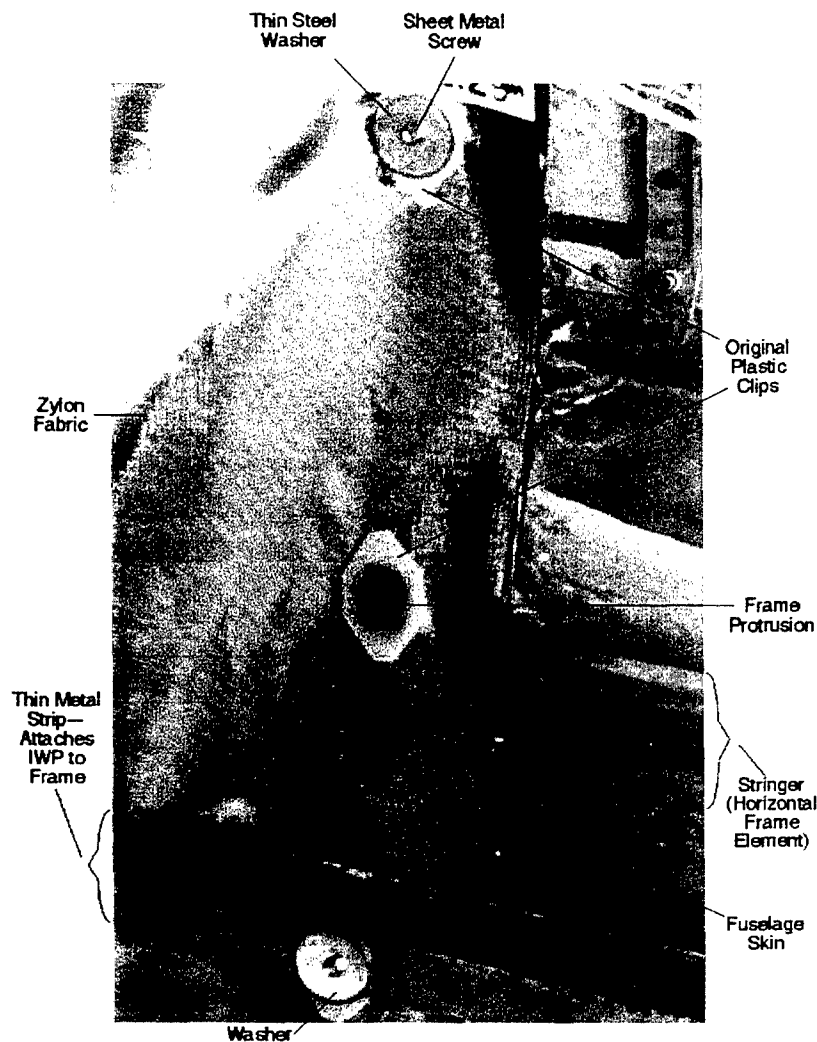
FIGURE 3. DETAIL OF FABRIC BARRIER INSTALLATION SHOWING ORIGINAL PLASTIC CLIPS AND ADDED METAL WASHERS AND SCREWS

After it had been determined that the flexible plastic clips, which are used to hold the insulation blanket in place on the frame protrusions, had failed to prevent the fabric barrier from slipping off the frame protrusions in some of the higher-energy tests. Thin, wide metal washers (called "fender" washers) were then screwed onto the frame protrusions (see figure 3) to assist in retention of the fabric. These washers were used only on the frame protrusions that were not in the same horizontal band as the impact region. For tests that extended over three vertical fuselage frame segments, the washers were used only on the outermost frame protrusions.

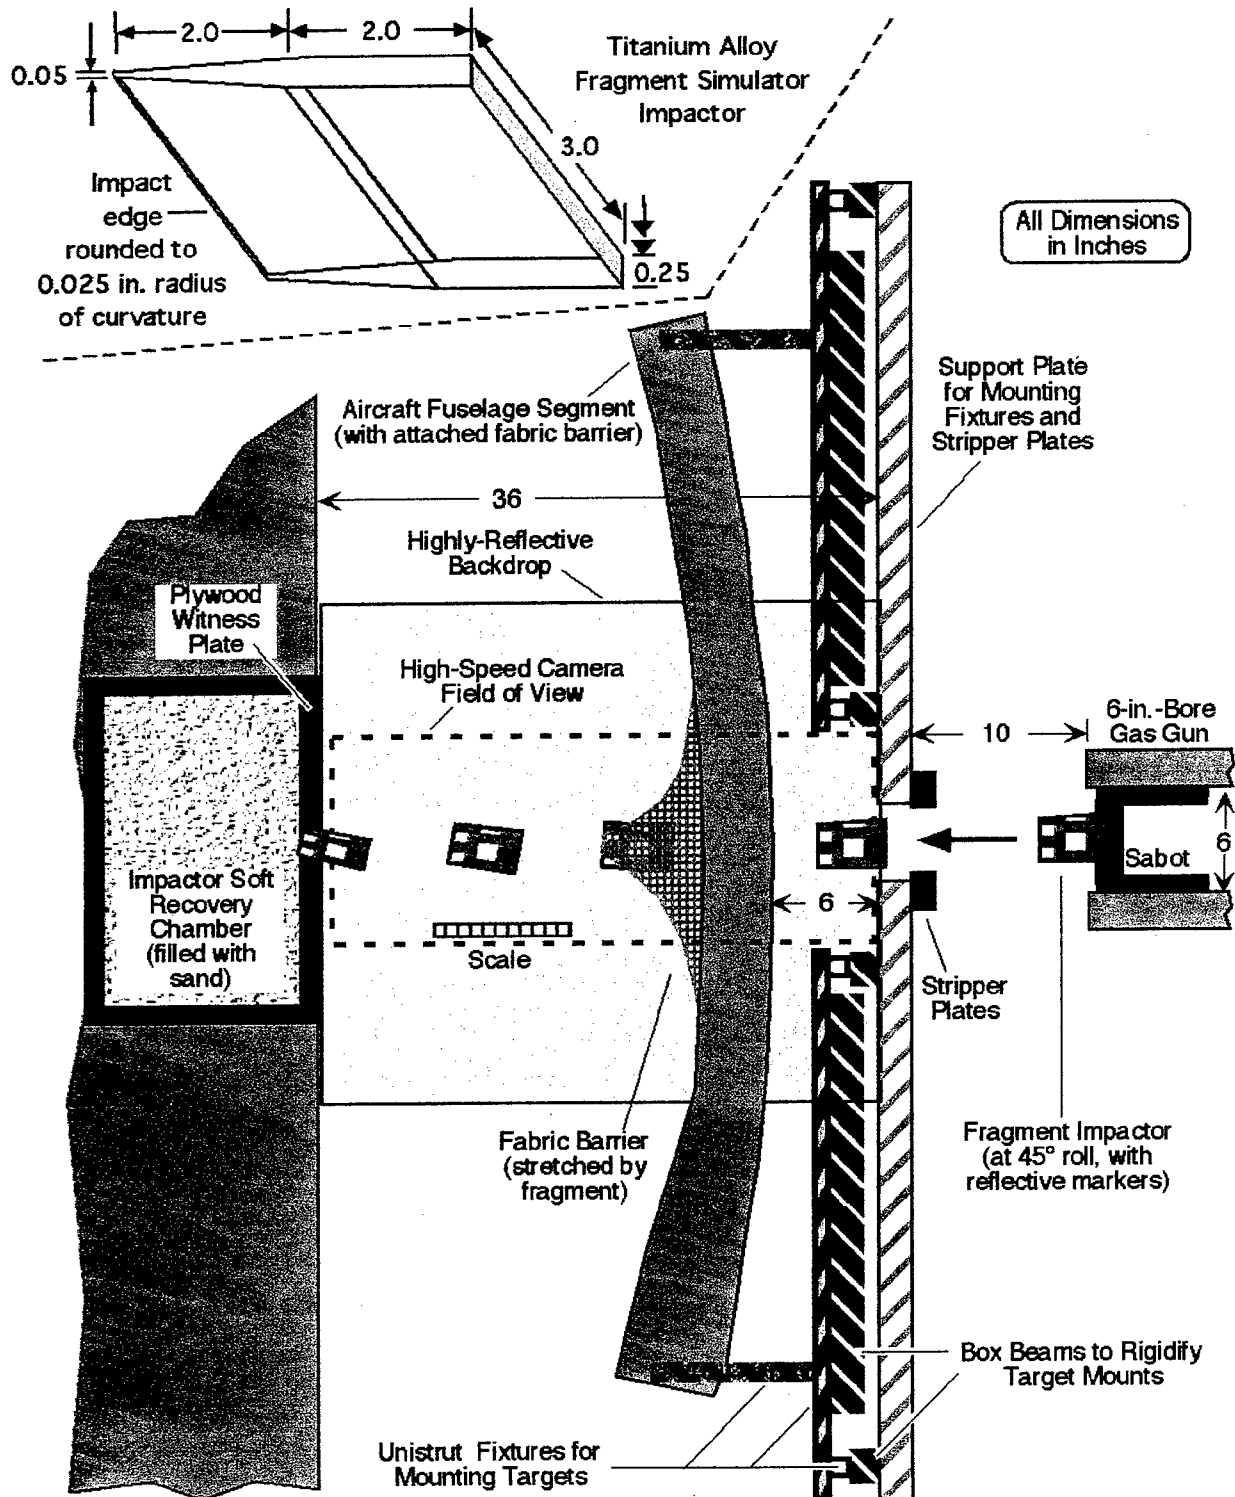
FIGURE 6. SCHEMATIC OF IMPACT TEST CONFIGURATION WITH FABRIC BARRIER ATTACHED TO FUSELAGE SEGMENT

The titanium alloy fragment impactors used in these tests (see figure 6) are similar to the standard fragments described above for the China Lake tests. They are 4.0 in. (10.2 cm) long by 3.0 in. (7.6 cm) wide, with a thickness of 0.25 in. (0.62 cm) that tapers from the mid-point down to 0.05 in. (0.13 cm) at the impact end, where the edges are slightly rounded. The impactors weigh roughly 0.4 lb (175 g), and they are mounted at the front of a sabot, which is accelerated down the barrel of the gas gun. Two fiber-optic light sensors located near the end of the barrel record the passage of alternate light and dark circumferential strips on the outside of the sabot, allowing the velocity of the sabot to be determined. The sabot is stopped by the stripper plates, while the fragment travels a short distance on its own before impacting the target.

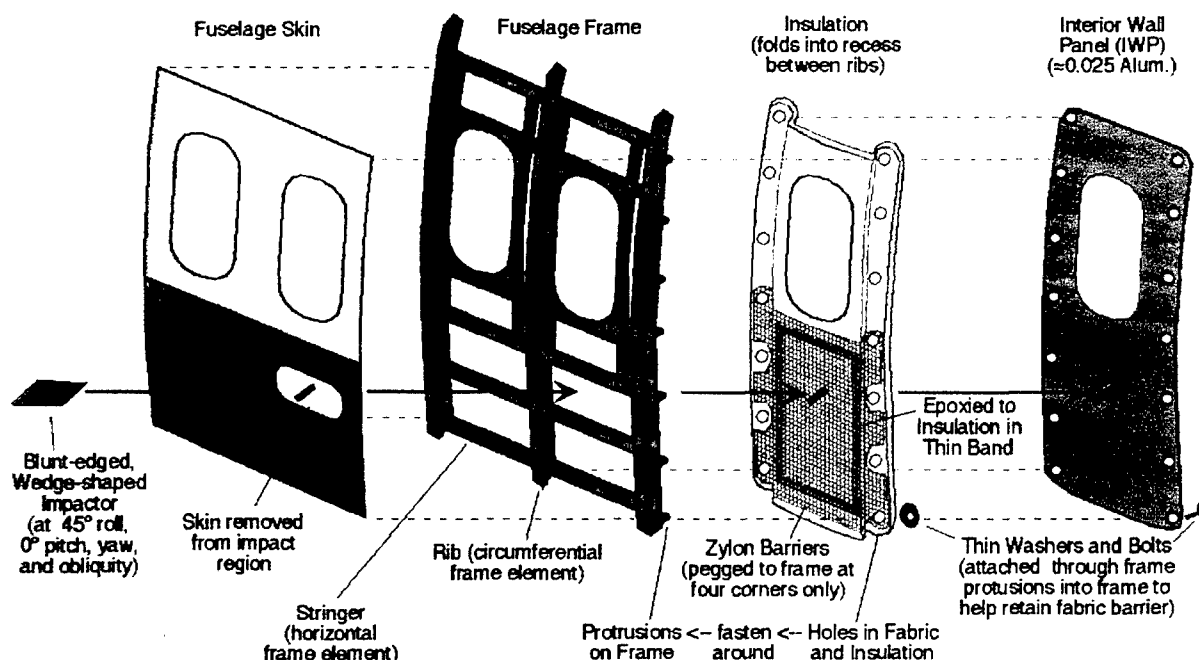
FIGURE 7. BARRIER MOUNTING SCHEME FOR TESTS USING FUSELAGE SECTION WITH FABRIC PEGGED AT FOUR CORNERS

During some of the tests using the fuselage section, the thin bolts securing the corners of the fabric to the frame failed, allowing the corner to come free. When larger bolts were substituted, the region of the frame where the bolt was attached deformed or failed, with a similar result. Also, the thin aluminum IWP sometimes deformed and became loose at one or more of its corners. Tests 110 through 115 were performed without a fuselage frame to reduce the likelihood of attachment failure (an undesired variation in the barrier boundary conditions) and to make the boundary conditions simpler and easier to model. Instead, the fabric was fastened at its four corners to the Unistrut mounting frame (as shown in figure 8) using stronger hardware, which was later redesigned to decrease the likelihood of the fabric slipping off the hardware, even after significant deformation of the fabric corner. The new hardware reduced the incidence of corner failure by slip-off or hardware failure, but there were still occasional incidences of corner failure by fabric tearing if the hole was too close to the fabric edge.

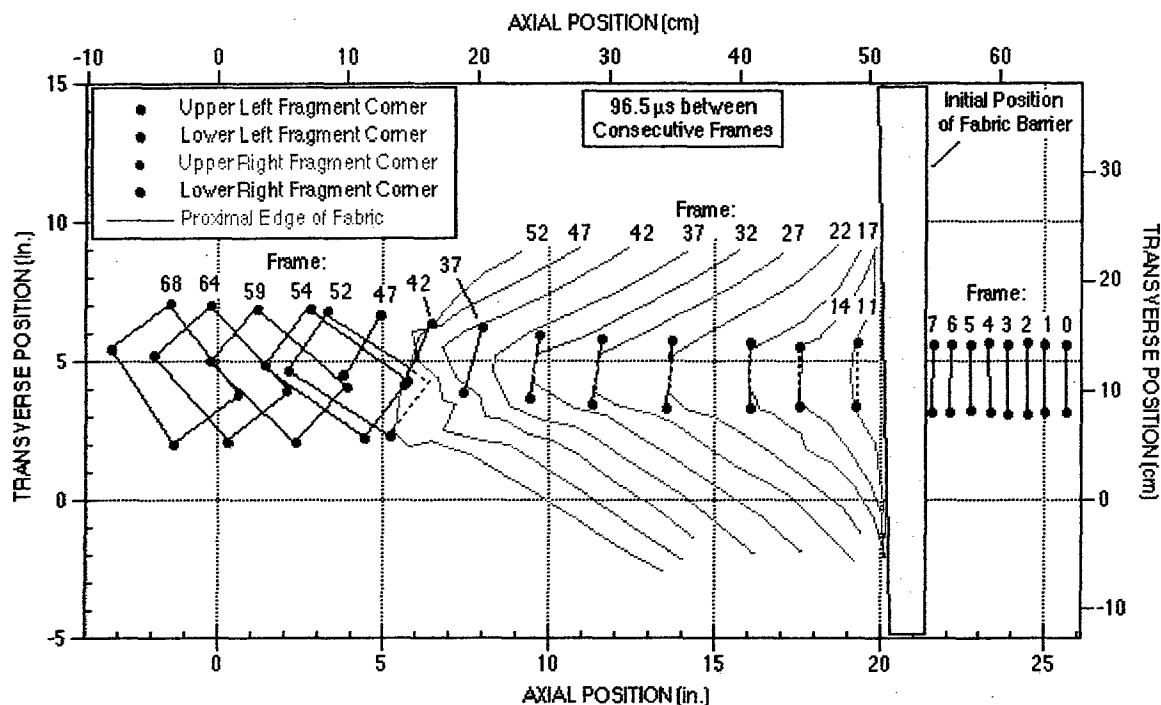
FIGURE 9. SILHOUETTES OF FRAGMENT AND FABRIC MOTION DURING IMPACT TEST 114

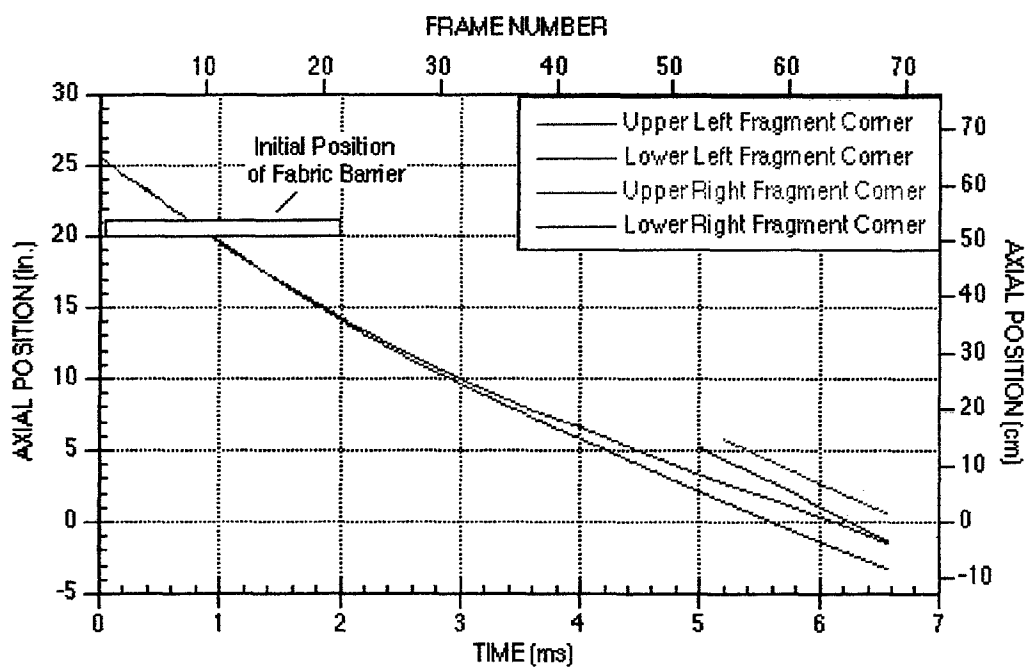
FIGURE 10. AXIAL POSITION OF VISIBLE FRAGMENT CORNERS IN TEST 114

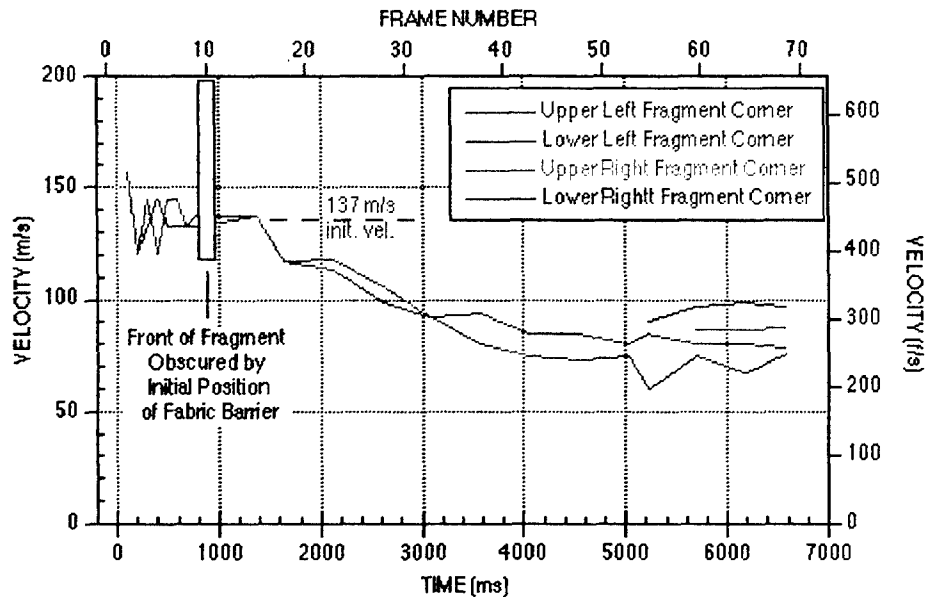
FIGURE 11. AXIAL VELOCITY OF VISIBLE FRAGMENT CORNERS IN TEST 114

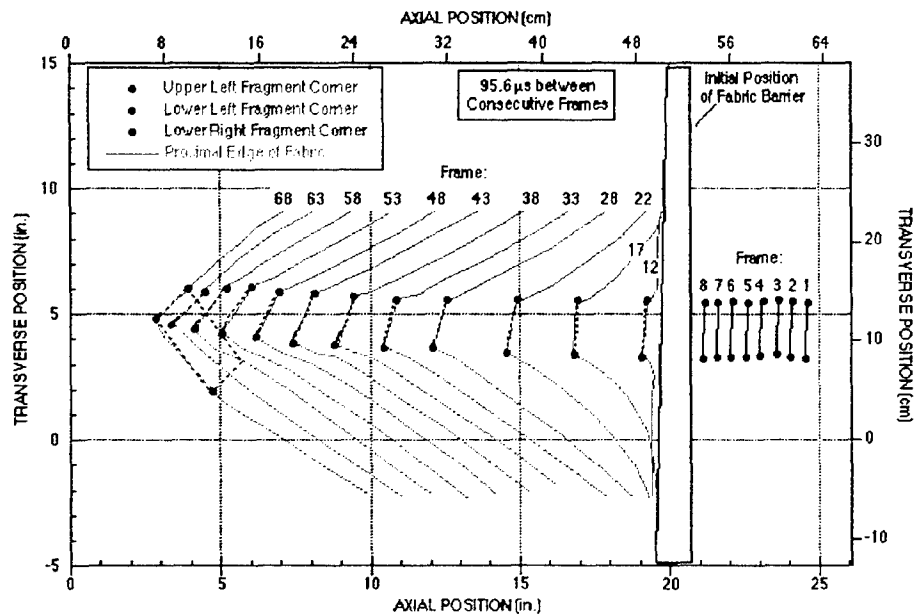
FIGURE 12. SILHOUETTES OF FRAGMENT AND FABRIC MOTION DURING IMPACT TEST 115

Figures 12 through 14 are the same three graphs for test 115. For this test, only the lower front corner of the fragment perforated the fabric (by frame 28). The fragment continued to deform the fabric, while it decelerated and rotated. The location of the lower back fragment corner is apparent in frame 68, but after that no clear outline of the fragment is visible. The fragment did not yet reach zero axial velocity at that time. Since the fragment did not completely perforate the fabric, and since there was no mark on the witness plate to denote any impact, the residual fragment velocity was deemed to be zero (three of the four fabric corners remained fastened to the frame).

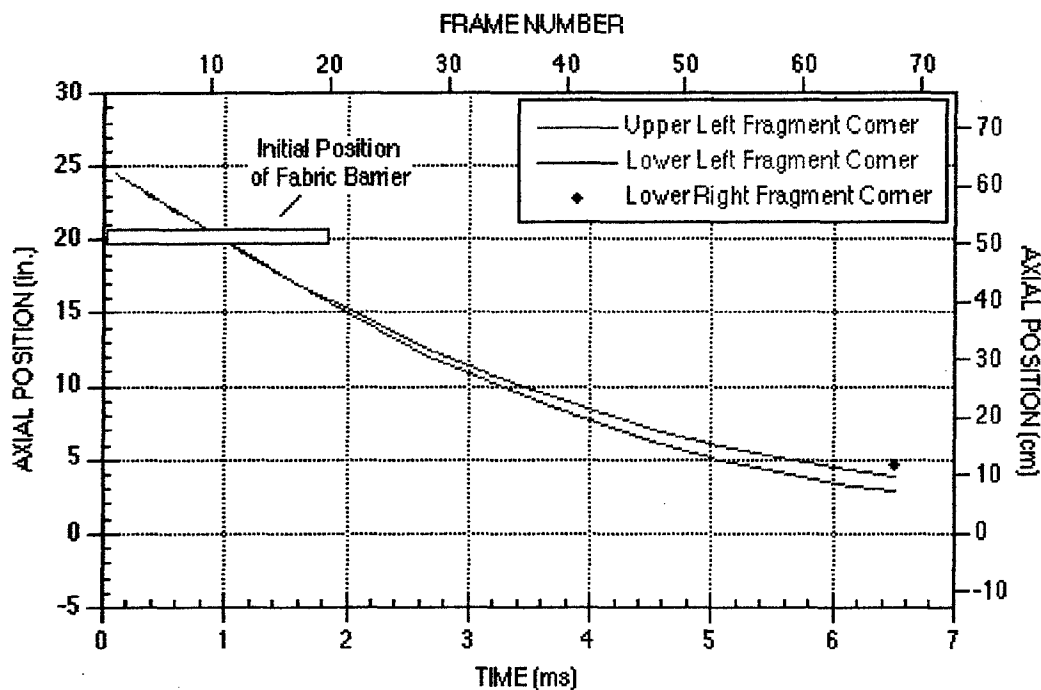
FIGURE 13. AXIAL POSITION OF VISIBLE FRAGMENT CORNERS IN TEST 115

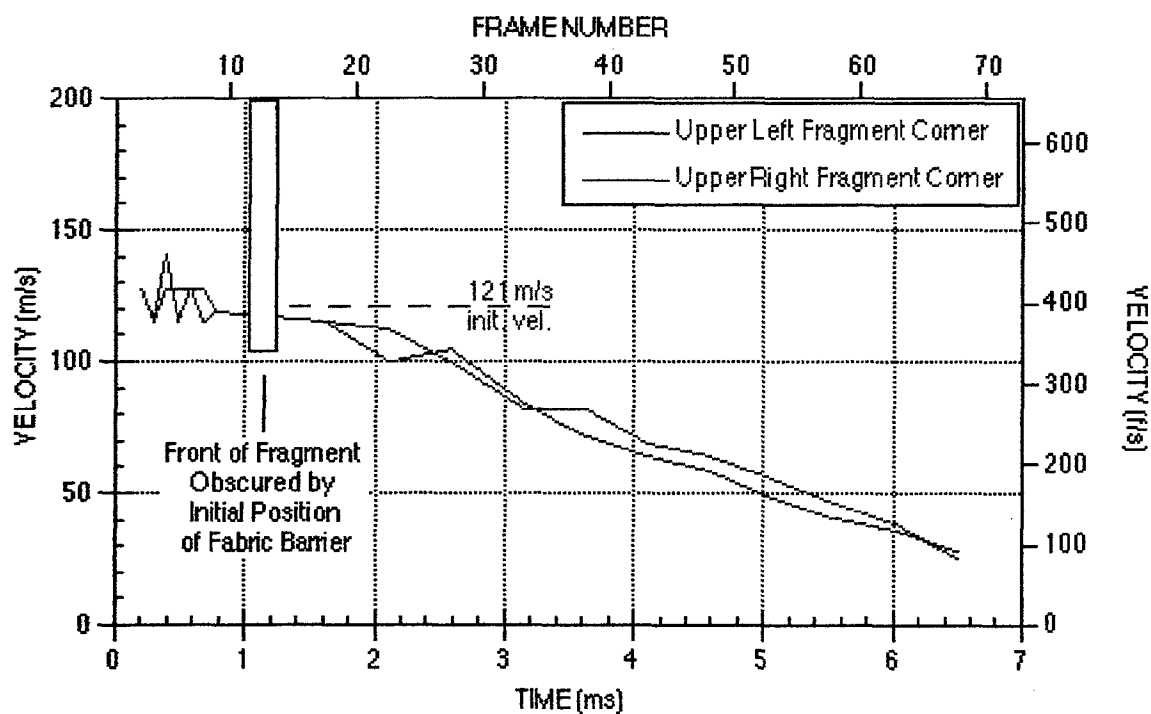
FIGURE 14. AXIAL VELOCITY OF VISIBLE FRAGMENT CORNERS IN TEST 115

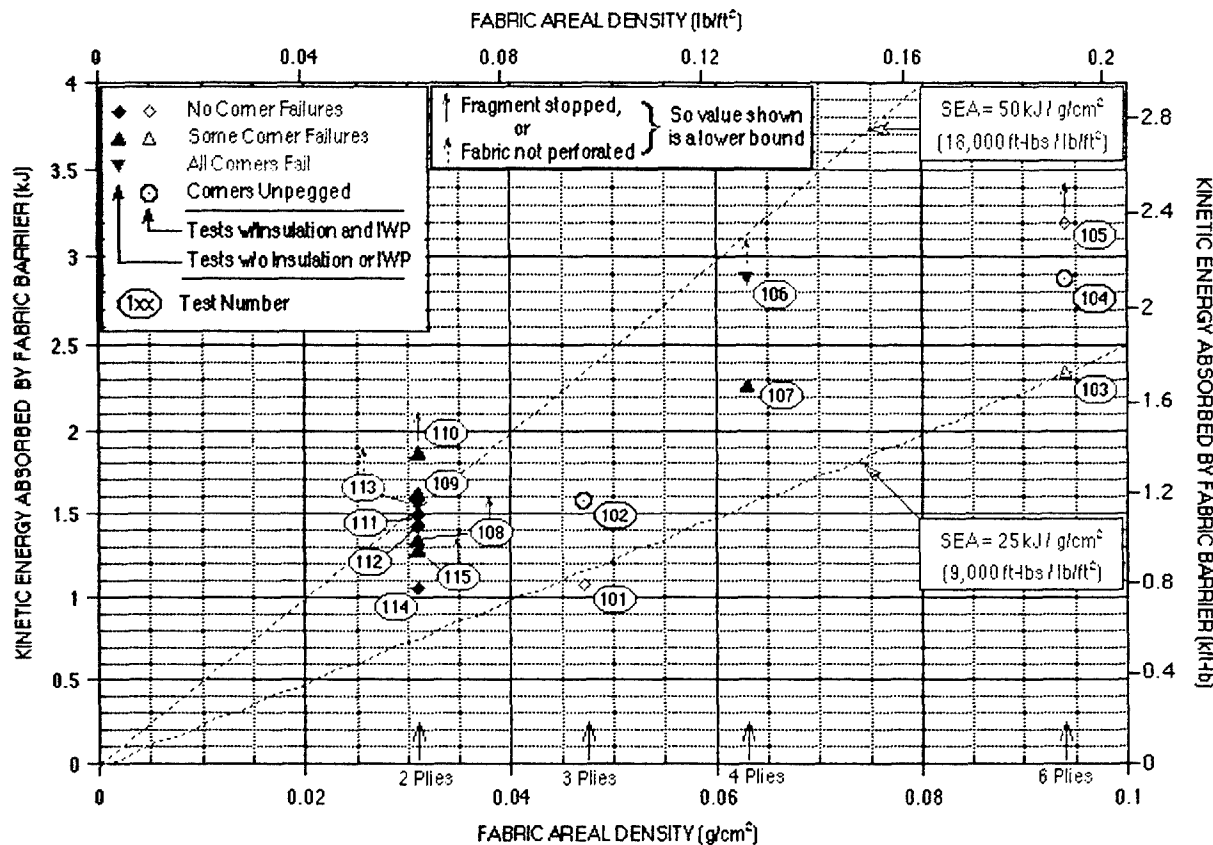
FIGURE 15. RESULTS OF LARGE-SCALE FRAGMENT BARRIER IMPACT TESTS WITH ZYLON FABRIC

TEST RESULTS—ENERGY ABSORPTION. The energy absorption and areal density values shown in table 3 are plotted in figure 15. The SEAs range from 23 to >60 kJ/g/cm² (8 to >20 kft-lb/lb/ft²), which are somewhat less than the 52 to ≥ 66 kJ/g/cm² (19 to ≥ 24 kft-lb/lb/ft²) range of SEAs for the same type of fragment impacting the same Zylon fabric in the second series of fuselage impact tests at China Lake. This is reasonable, since the impact areas (and hence the number of yarns that need to be cut to allow penetration) in these tests were significantly less (because of the nearly 0° yaw attained) than in the China Lake tests (where the yaws were large).

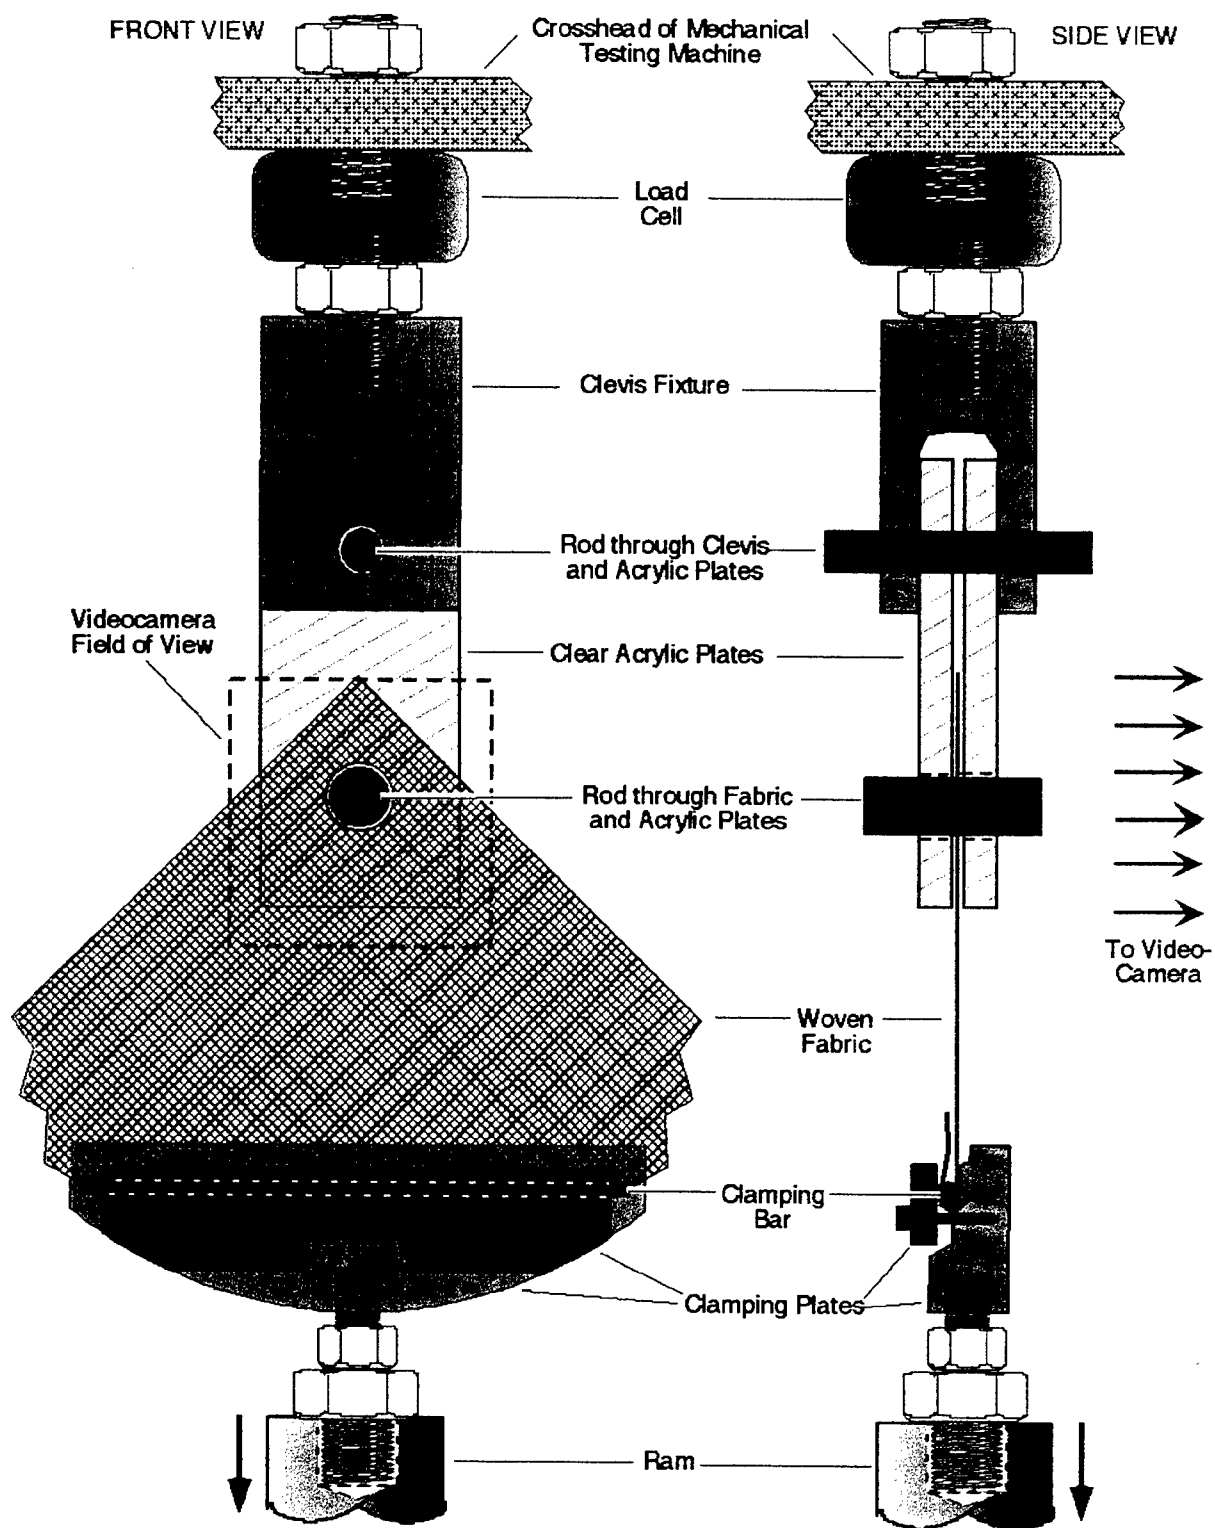
FIGURE 17. EXPERIMENTAL DESIGN FOR FABRIC CORNER FAILURE TESTS

A laboratory test, called the fabric corner failure test, was designed to examine fabric behavior in the vicinity of a held corner. Figure 17 shows the design for a fabric that is pegged through a hole near the corner. Using many of the same fixtures from the previously reported [4] quasi-static penetration (pull) and yarn pullout tests, this test will produce detailed video images and acoustic records of fabric deformation and failure around a pegged hole, while recording the deflection of the peg and the load on the fabric. The size and shape of the hole and the peg and the proximity to the fabric edge can be varied. Other potentially energy-absorbing variations can be tested, such as multiple-pegged holes or additional unpegged holes in the vicinity of the pegged holes. Holding the fabric corner by means other than pegging through a hole (such as winding the fabric around a flattened rod) should also be tested. A test series, with the parameters to be determined in conjunction with computational simulations, is planned for the next program year.

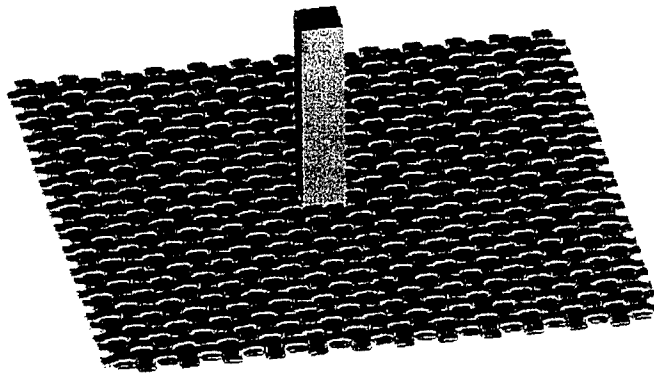
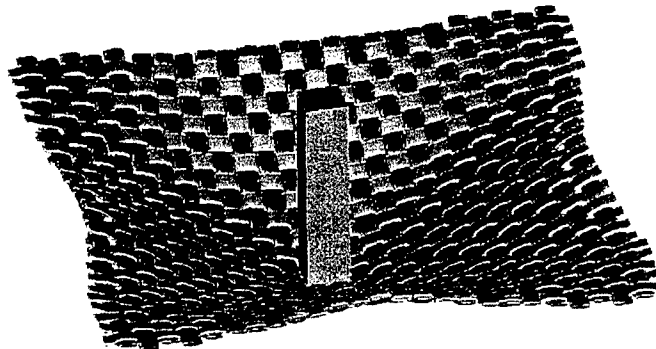
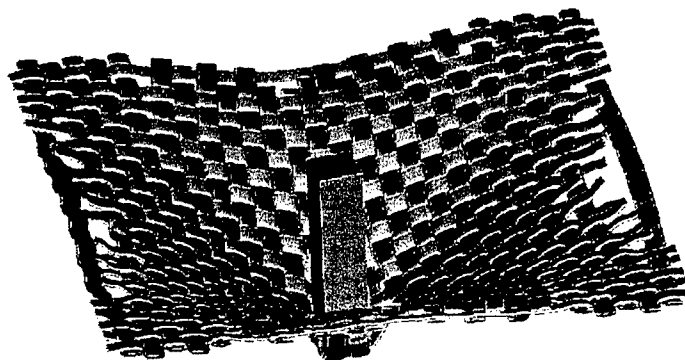
FIGURE 18. CALCULATED RESPONSE OF FABRIC HELD AT CORNERS

The current simulation involved gripping the fabric on corners only. As in previous simulations, the fabric modeled was a square patch of 25 x 25 yarns. At the corners, five yarns were held in each direction. As shown in figure 18(a), the fabric was impacted with a 120-m/s fragment aligned over a 2 x 2 yarn square in the center of the fabric. Thus, none of the yarns that were directly hit with the fragment were gripped. It was expected that this method of gripping would result in fewer broken yarns and a longer duration-resisting load.

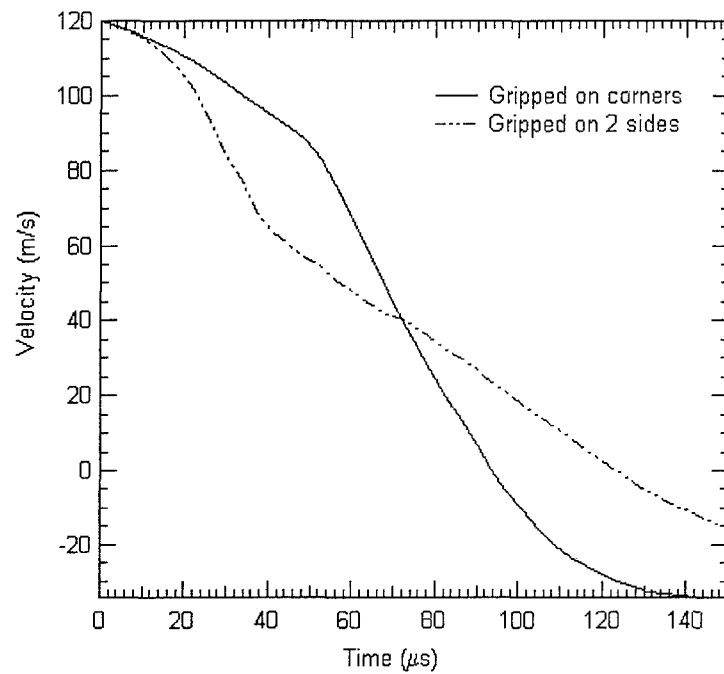
FIGURE 19. CALCULATED VELOCITIES FOR FABRIC GRIPPED ON CORNERS AND GRIPPED ON TWO SIDES

Figure 19 shows the calculated velocity histories of the fragment for the corner-held simulation and for the simulation gripped on two edges. Initially, the fabric gripped on the corners slows the fragment more gradually than the fabric gripped on two edges; but by 50 μ s, the corner-held fabric slows the fragment more quickly. By 50 μ s, the held yarns that were impacted for the two-edge-gripped case have broken. As seen in figure 19, gripping the fabric on the corners stops the fragment at about 90 μ s, compared to 120 μ s when the fabric is gripped on two edges.

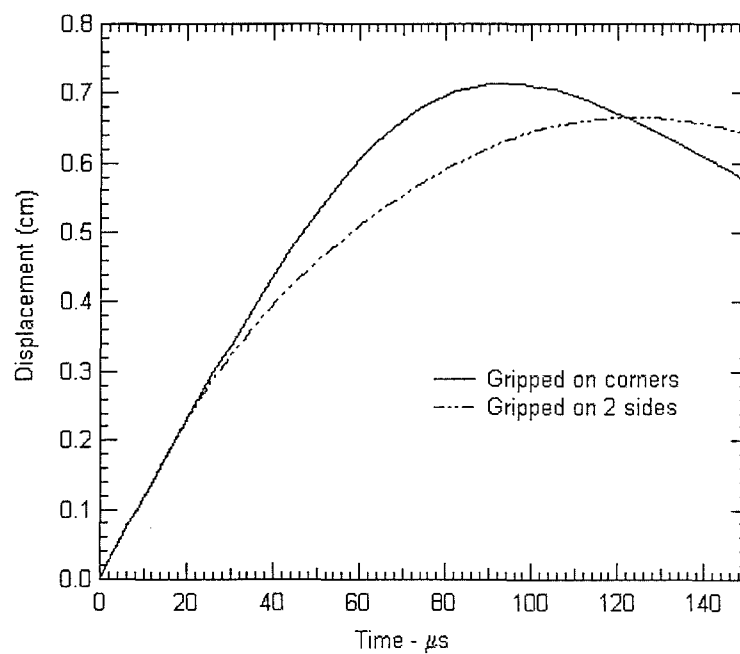
FIGURE 20. CALCULATED DISPLACEMENTS FOR FABRIC IMPACT SIMULATIONS

Figure 20 shows the calculated displacements of the fragment for the two cases. At the time when the fragment is just stopped, the peak displacement of the fabric is slightly higher (0.72 cm vs. 0.66 cm) for the fabric gripped on the corners. These simulations confirm that fabric gripping is a key parameter for optimizing barrier design and suggest that it is advantageous to grip the fabric in such a way that the impacted yarns are not broken.

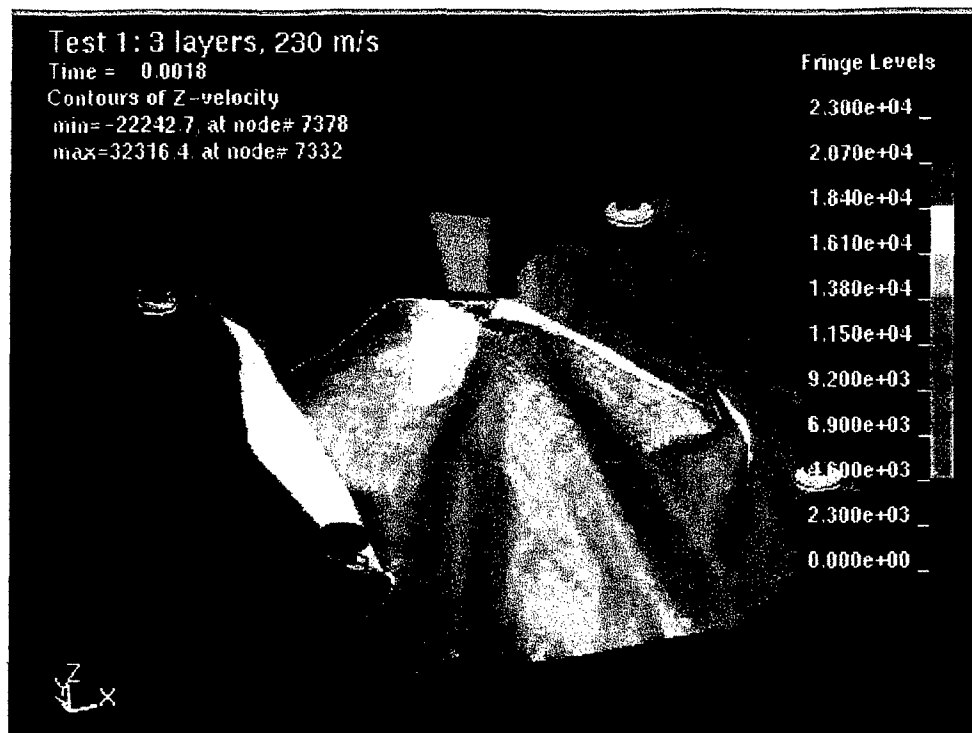
FIGURE 22. SIMULATION OF TEST 101 AT 1.8 ms
(Fragment impacting from bottom to top)

Figure 22 shows the simulation at a time of 1.8 ms. By this time, the fragment has completely penetrated the fabric. As seen by the deformation of the fabric, the fragment penetration occurs before the fabric has completely stretched out. The calculated residual velocity of the fragment was 180 m/s and the measured value was 202 m/s, thus the model is too strong in this case. An animation of this simulation can be viewed on the project web site at http://www.sri.com/poulter/air_safety/design_model.html.

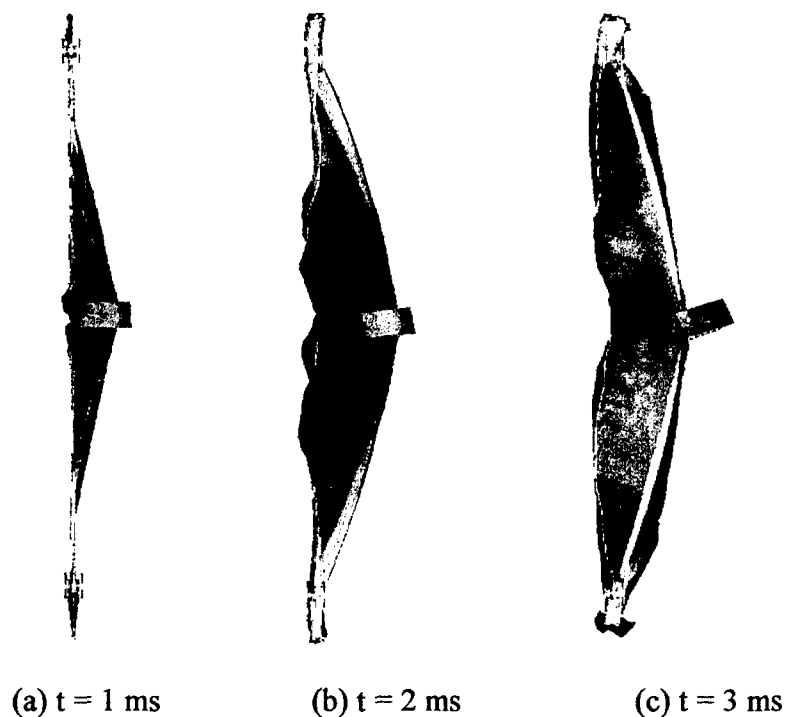
FIGURE 23. SIMULATION OF TEST 114

SIMULATION OF TEST 114. Simulation results for large-scale test 114 are shown in figure 23. Compared to test 101, test 114 was a larger target and had no sag in the fabric. In this figure, the fragment is traveling left to right, and the fabric was made transparent so the fragment could be seen. At 1 ms, the fragment velocity was 100 m/s; at 2 ms, the velocity was 55 m/s; and at 3 ms, the fragment had penetrated the fabric with a residual velocity of 20 m/s. The residual velocity measured in the experiment was 83 m/s. Similar to the simulation of test 101, the model is too strong. In terms of energy, the model overpredicts the energy absorbed by 0.58 kJ. Preliminary investigation of the deformation of the fabric shows that the model is too stiff (i.e., the simulation shows less deformation of the fabric than seen in the experiment).

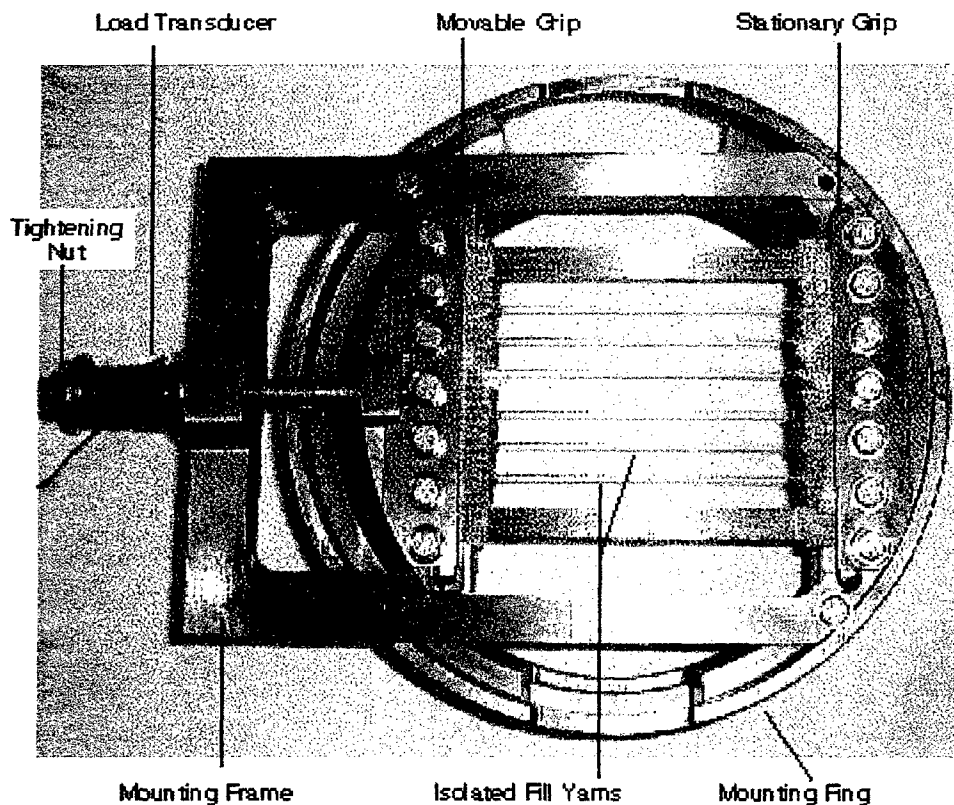
FIGURE A-1. ZYLON FABRIC SPECIMEN WITH ISOLATED FILL YARNS
PREPARED FOR TRANSVERSE CUT TESTS

The fabric specimens were 5 in. wide and 12 in. long in the direction of fill yarns. As shown in figure A-1, they were tightly gripped at two edges in the fabric-holding fixture previously used for the yarn pullout tests [A-2]. The fabric length between grips (i.e., the yarn gauge length) was ≈ 6.5 in. To isolate individual fill yarns for testing (to avoid any contact between the blade and adjacent yarns), the fill yarns between the isolated fills to be tested were removed, along with all of the warp yarns, in the region between the grips. Each fabric sample had approximately six isolated fill yarns with a space of 0.5 in. between them. At both edges of the sample, 15 fill yarns remained to keep the sample aligned during mounting and testing.

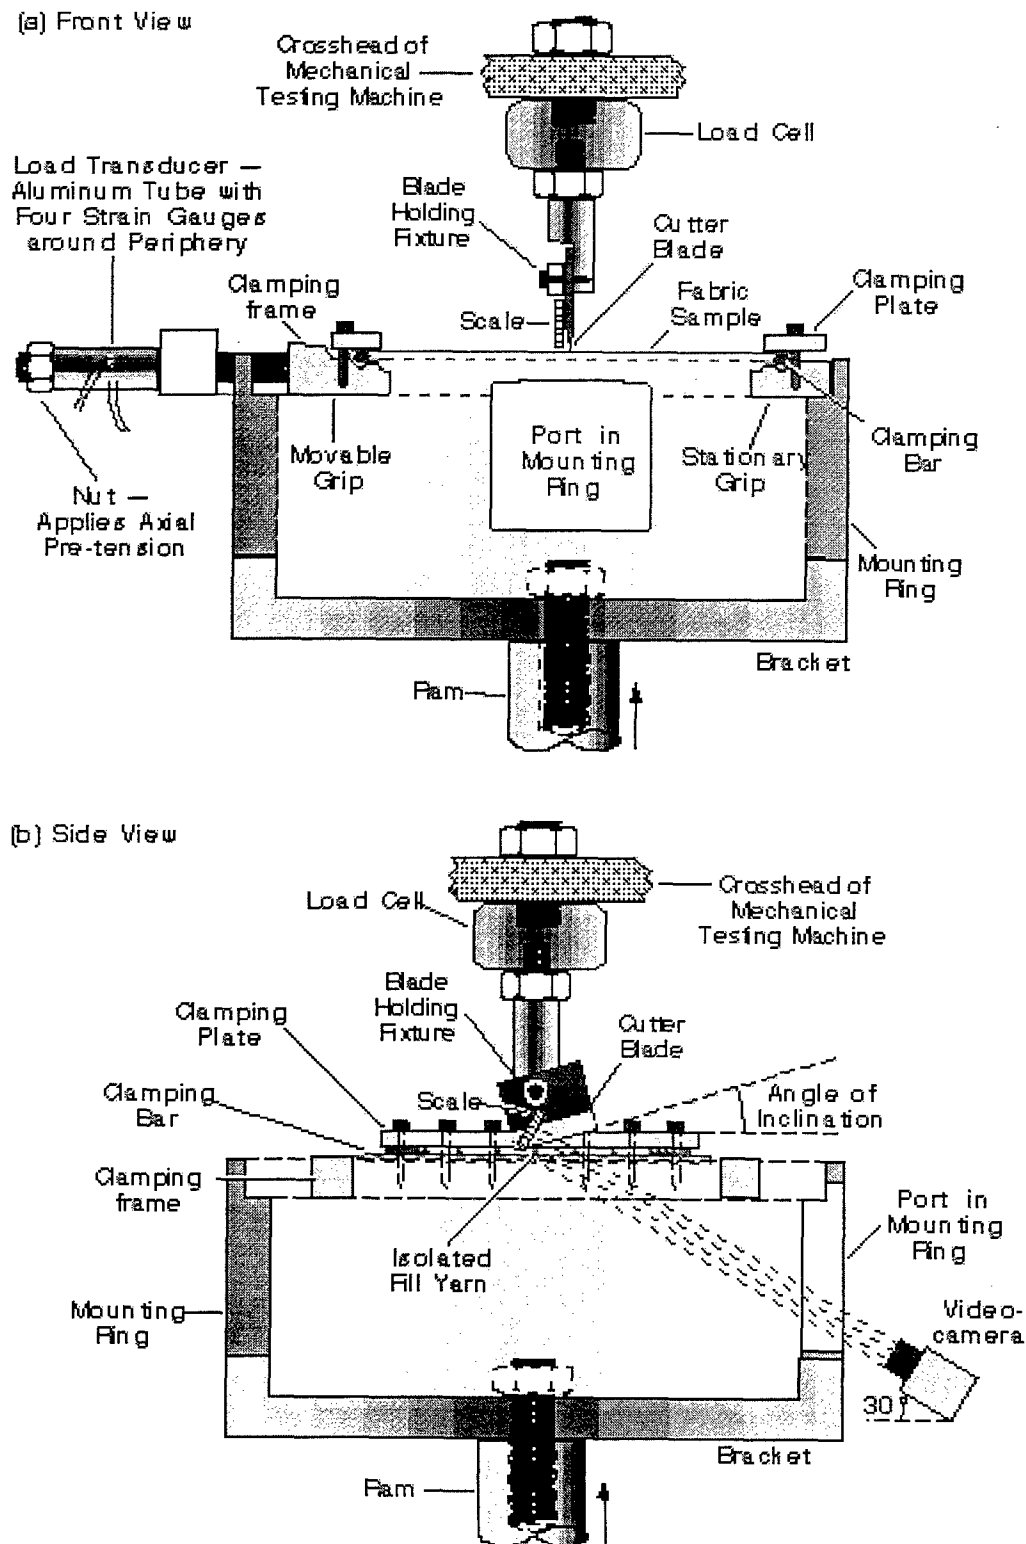
FIGURE A-3. SETUP FOR YARN TRANSVERSE CUT TESTS

TEST PROCEDURE. Figure A-3 shows the experimental setup for the yarn transverse cut tests. The fabric sample with the isolated fill yarns was mounted horizontally in a frame, which was affixed atop the ram of the MTS servo-hydraulic mechanical testing machine. The cutter blade was held above the fabric and attached to the crosshead of the MTS machine through a load cell, which measured the load on the cutter (or the transverse load on the mid-point of the yarn). The blade was attached at different angles of inclination (0° , 7.5° , 15° , 30° , or 45°) with respect to the plane of the fabric. The upward movement of the ram (at a constant ram rate of 0.01 in./s) pushed the yarn up against the cutter blade. The ram stroke (which equals the deflection of the yarn mid-point only for a 0° blade inclination angle, for which there is no slip of the yarn along the blade edge) and the transverse load on the yarn mid-point were recorded continuously throughout the test.

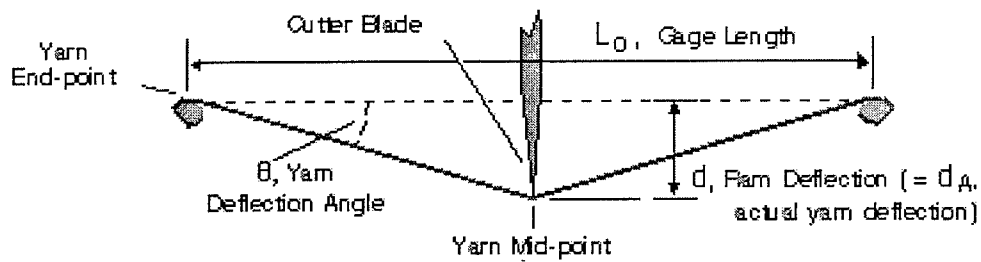
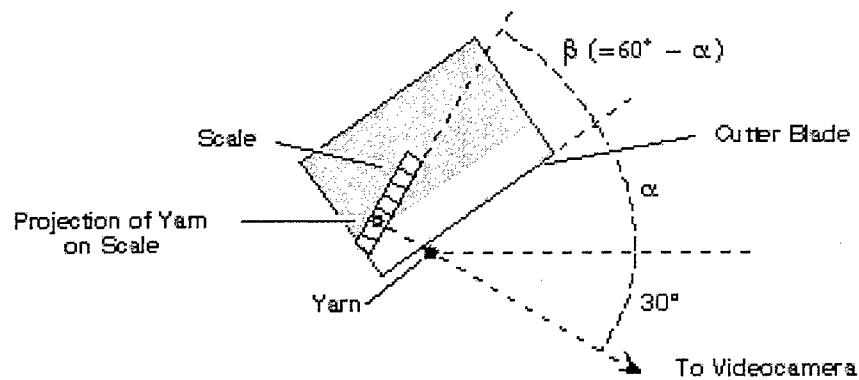
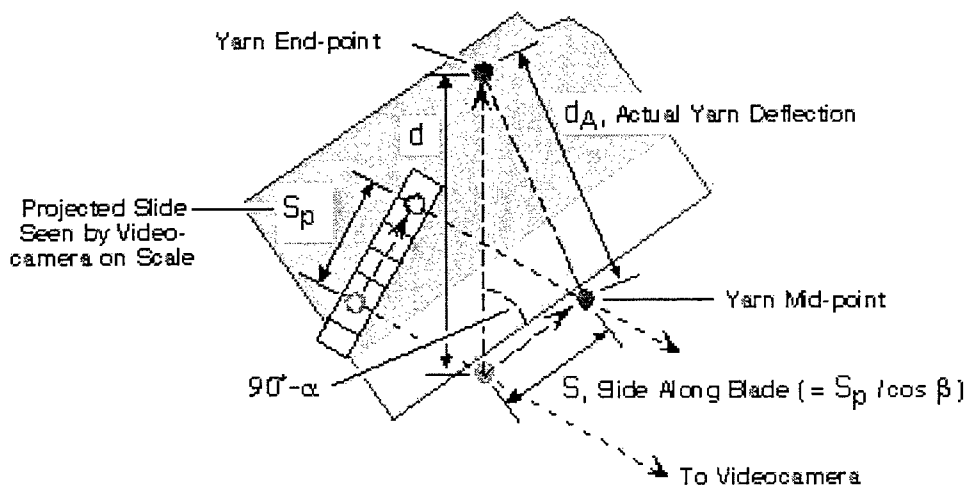
(a) Front view after ram deflection d , with 0° angle of inclination

(b) Side view at instant of contact, with angle of inclination α

(c) Side view after ram deflection, d , resulting in yarn slide along blade, S

FIGURE A-4. GEOMETRY FOR STRAIN ANALYSIS OF TRANSVERSE CUT TESTS
